TEST REPORT

Report Number: 002-253025

Client: TOTO USA Inc.
5351 E. Jurupa St.
Ontario, CA 91761

Sample Description: A vitreous China water closet. The unit was a one-piece, elongated bowl, 12” rough-in, single flush, 1.28 gpf gravity fed, high-efficiency water closet.

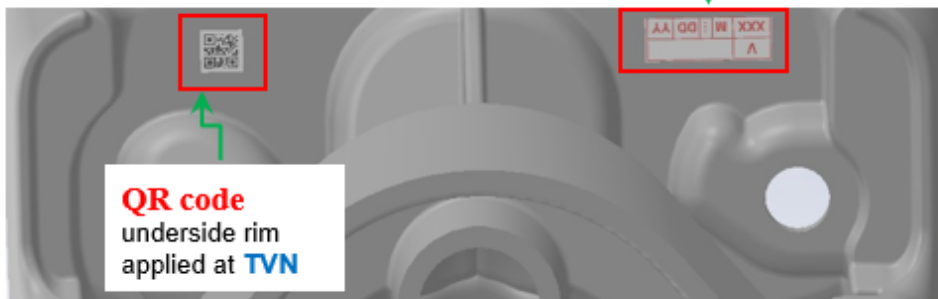
Casting No. stamped on back on inside at **TVN**

QR code
underside rim
applied at **TVN**
